POWER DISTRICT BUILDING NEEDS ASSESSMENTS

May 2015

Gainesville
Community
Redevelopment
Agency

WALKER
ARCHITECTS

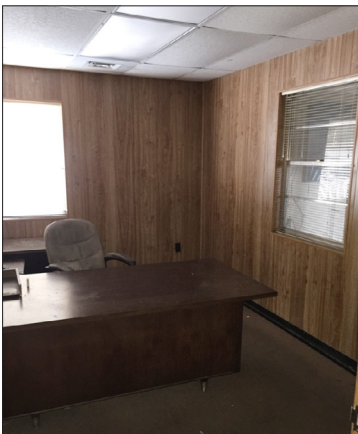
SYSTEM	CONDITION	RECOMMENDATION
Floor Coverings	Office Floors - Offices have three different types of floors installed. No floor cracking or severe wear was observed. System 1: Carpet. Glued down sheet carpet is in poor condition. (Located In several office spaces)

Office With Sagging Ceiling Tiles And Worn Carpeting

<p>The office areas should be completely renovated if they are to be reused.</p>
Ceiling System	Type 1: Lay-in acoustic ceiling tile. Most of the existing ceiling system is in poor condition and replacement is recommended. Batt insulation is present on top of the ceiling tile system. Type 2: Warehouse spaces are exposed to the building structure.

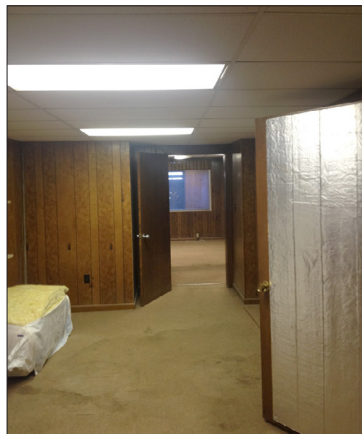
Office Area With Worn Carpeting

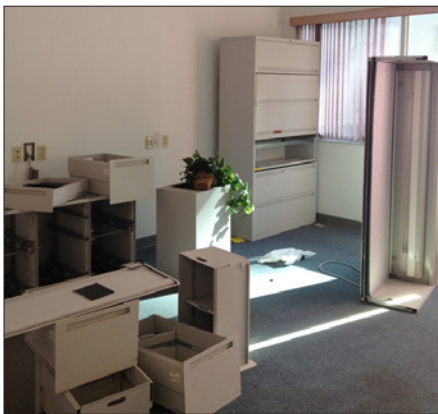
SYSTEM	CONDITION	RECOMMENDATION
Floor Coverings	System 1: Carpet. Glued down sheet carpet is in fair condition. (Offices, corridors)

Office With Worn And Dirty Carpet

Replace all finishes.
	System 2: Ceramic Tile. Varied sizes and colors and in fair condition. (Toilet rooms and lobby areas)	
Ceiling System	Type 1: Office spaces have standard sound absorbent 2x2 or 2x4 acoustic ceiling tile. There has been some exposure to moisture which is evidenced by the sagging tiles.

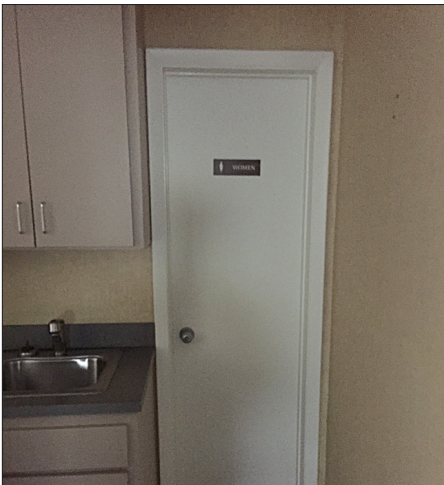
Toilet Room With Exterior Sink

Demolish plumbing stub-outs in existing offices.
Hot Water Systems	No hot water system was located during the survey.	
Other	There is a sink just outside of the restrooms in the main corridor. The sink is in poor condition.	Demolish existing sink. Install new sink to serve new tenant layout.

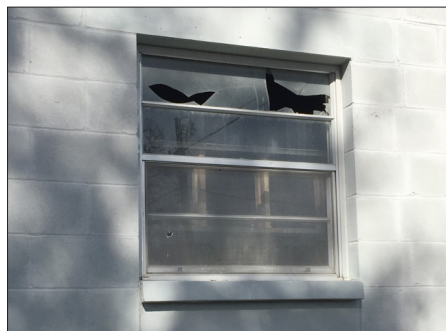
Broken Window Glass

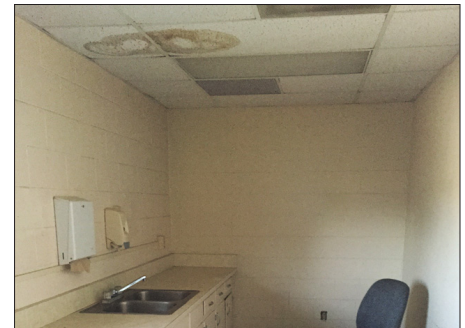
Water Damaged Ceiling Tiles

Repair water damage and roof leaks.

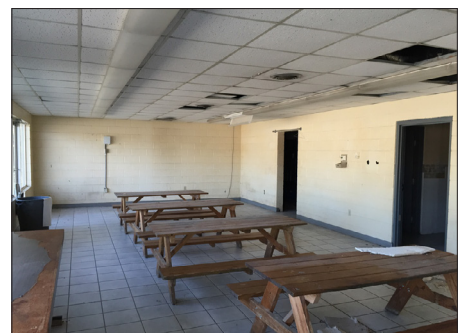
Break Area With Sagging Ceiling Tiles
