**PHASE I
ENVIRONMENTAL SITE ASSESSMENT
THREE CITY PARCELS
GAINESVILLE REGIONAL UTILITIES—
PARCEL 2**

ECT No. 070715-0100

September 2007

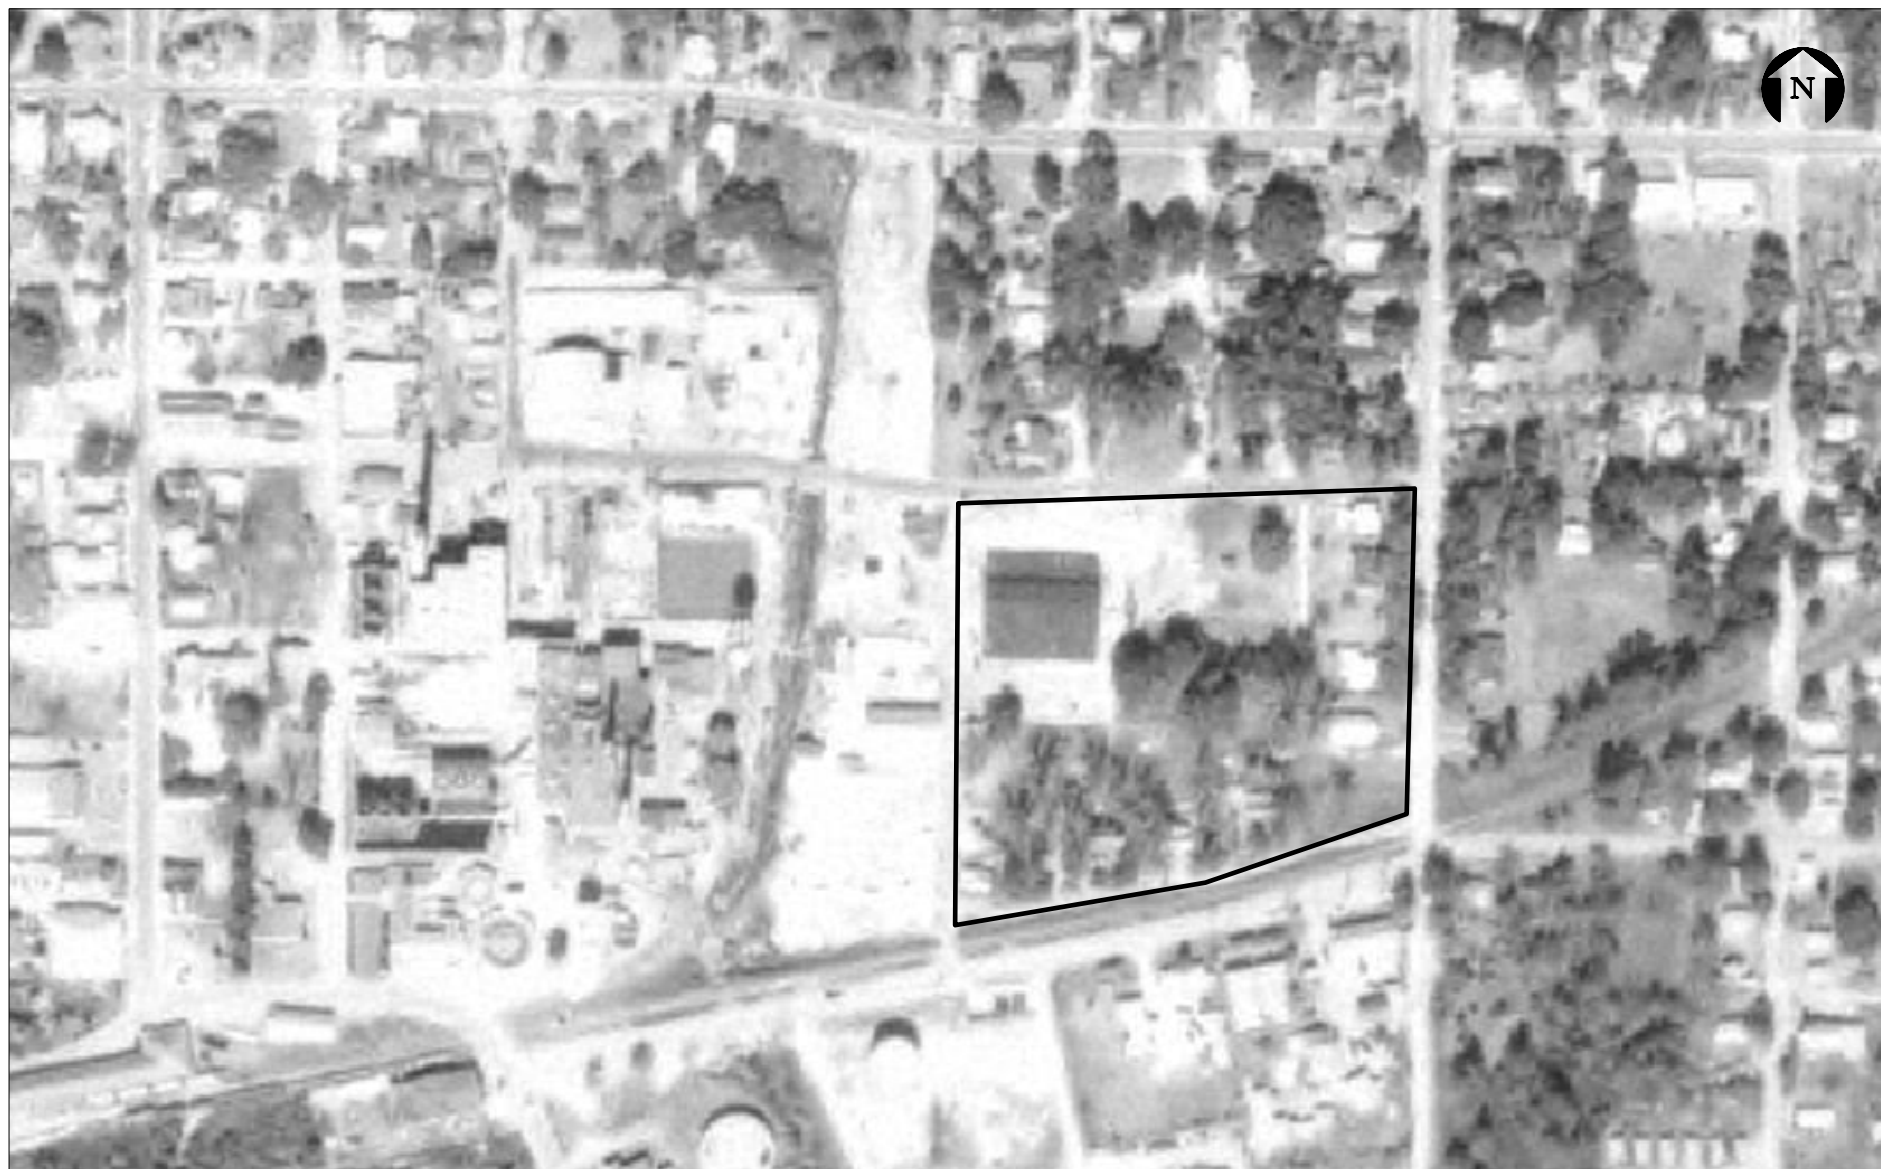
FIGURE 2.
1961 AERIAL PHOTOGRAPH
PARCEL-2

Historical aerial photographs were obtained from the Florida Department of Transportation Department Surveying and Mapping Office for the years 1964, 1971, 1982, 1994, and 2004. The aerial photographs for the years 1937, 1949, 1956, 1961, and 1968 were acquired from the University of Florida Map Library. The photographs were reviewed to identify former land uses onsite and in the vicinity of the subject property. The photographs consisted of low-altitude, black-and-white photographs. Brief descriptions of the subject property and vicinity, as observed in the aerial photographs, are presented below. Figure 2 is a copy of the 1961 aerial photograph which shows the beginning of the construction phase on the property.

No evidence of environmental impairment to the subject site was observed from the aerial photography review.

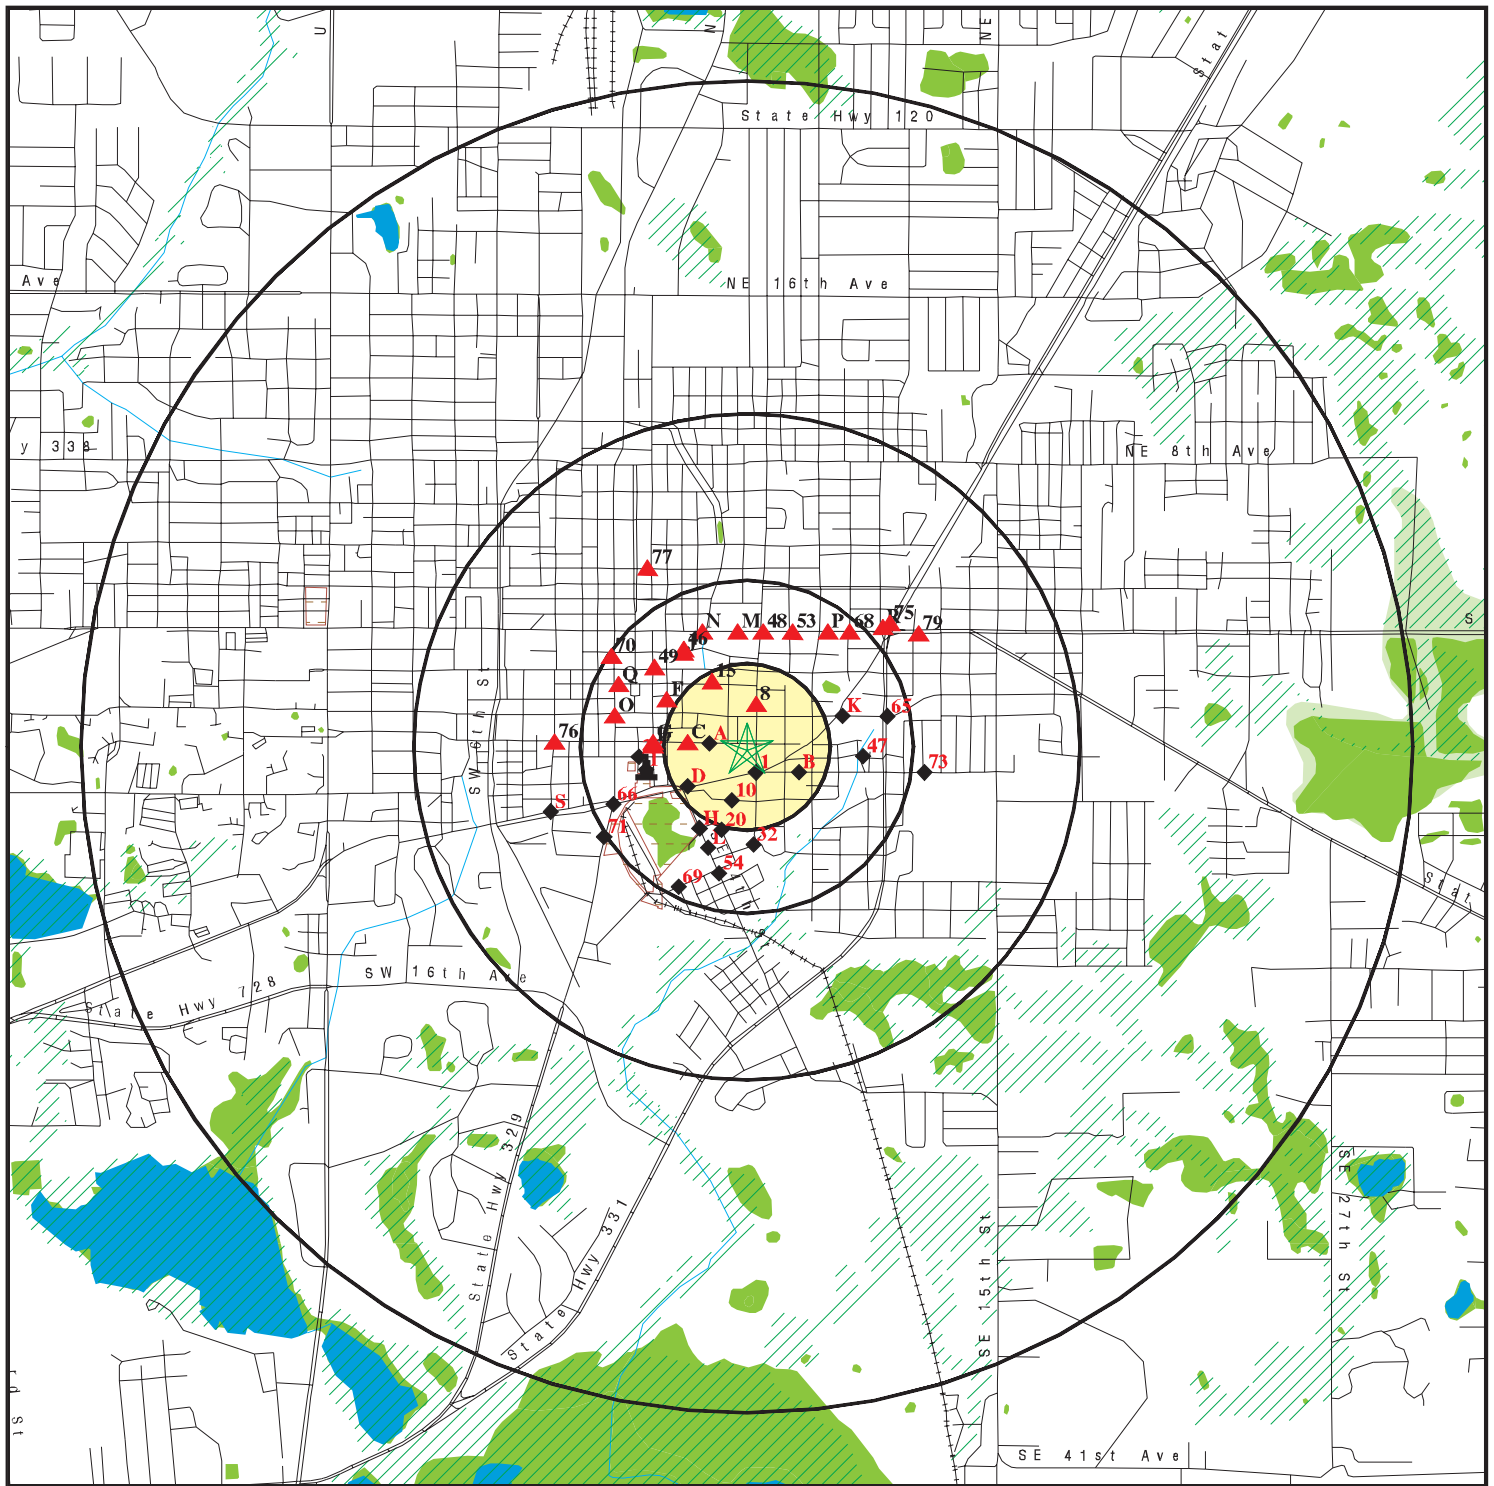
OVERVIEW MAP - 1975568.1s

★ Target Property

▲ Sites at elevations higher than or equal to the target property

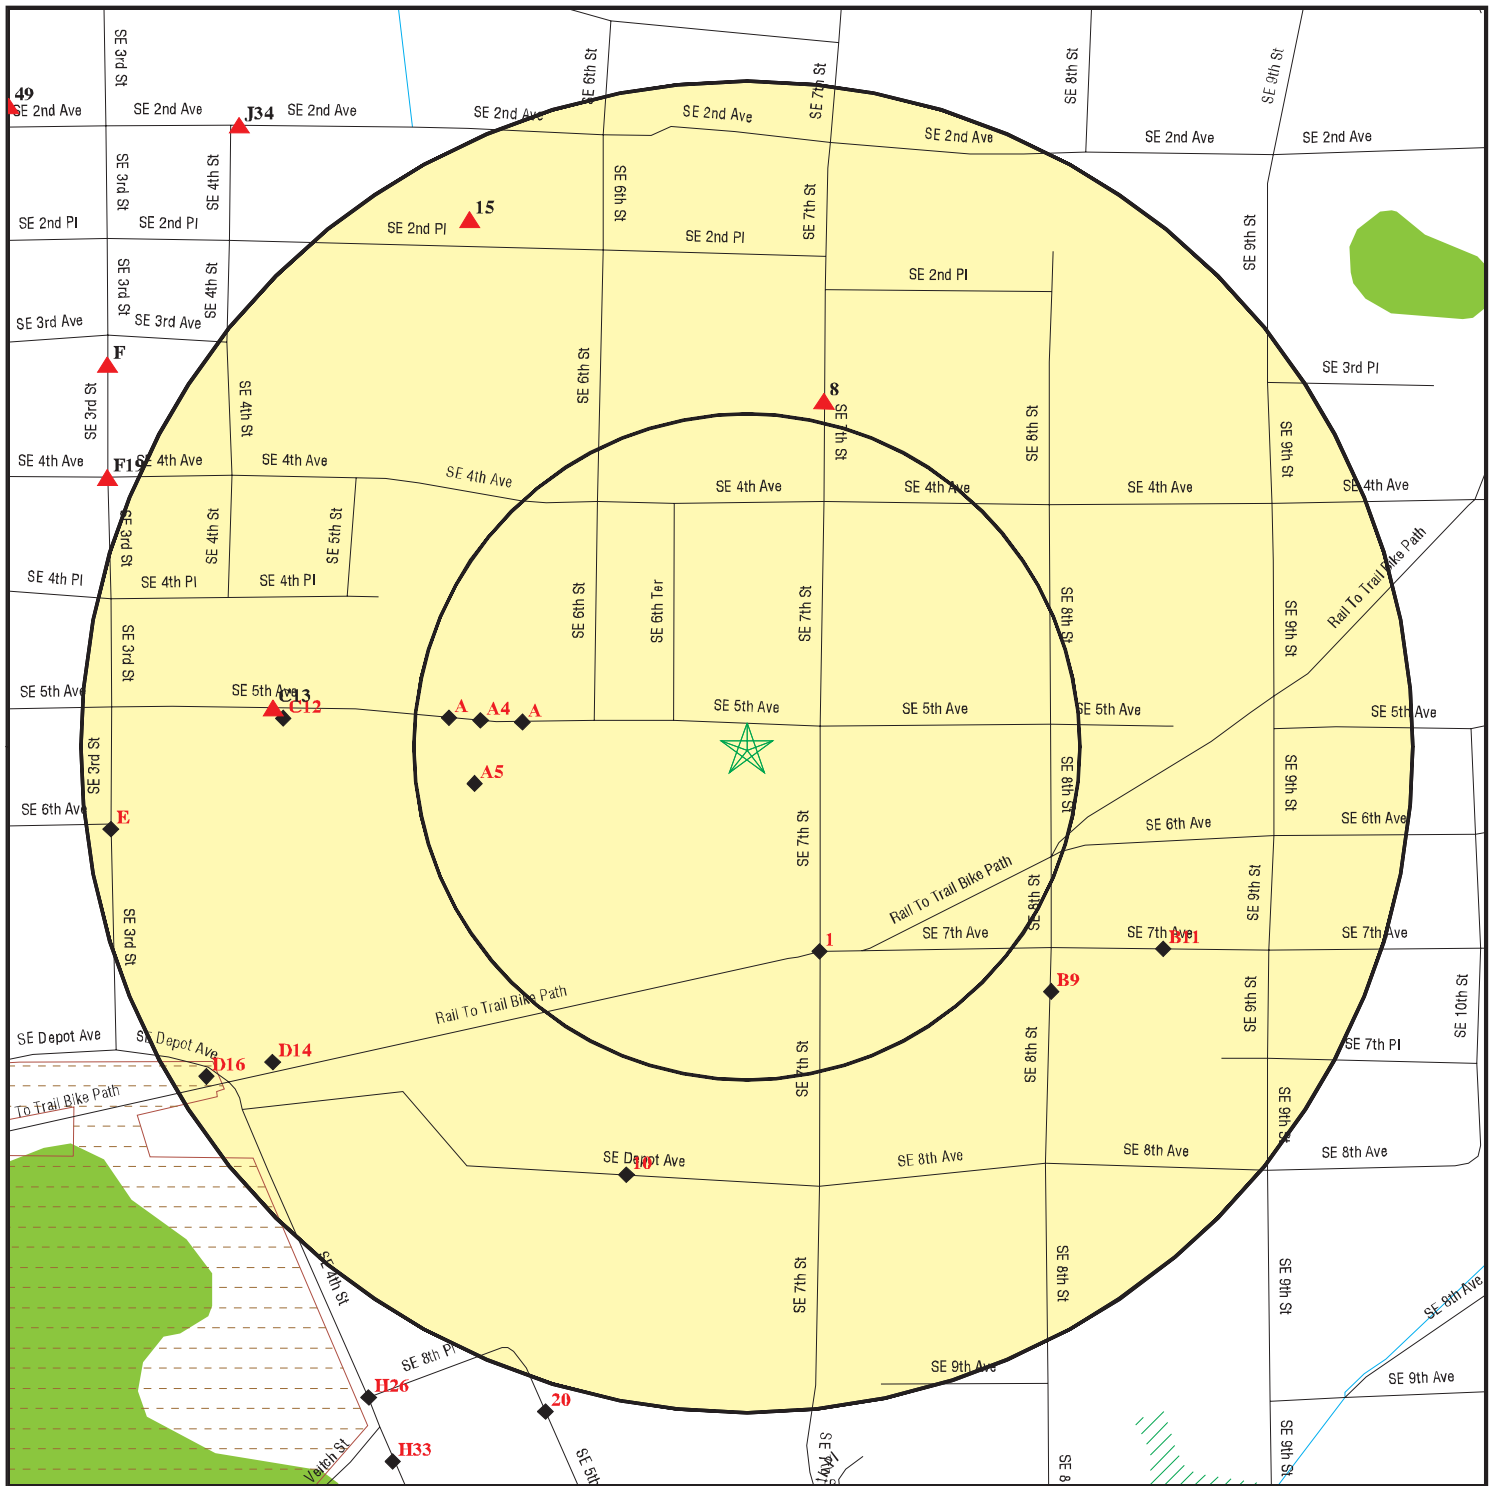
DETAIL MAP - 1975568.1s

- ★ Target Property
- ▲ Sites at elevations higher than or equal to the target property
- ◆ Sites at elevations lower than the target property
- Manufactured Gas Plants
- Sensitive Receptors
- National Priority List Sites
- Dept. Defense Sites

- Indian Reservations BIA
- Oil & Gas pipelines
- 100-year flood zone
- 500-year flood zone
- National Wetland Inventory
- State Wetlands

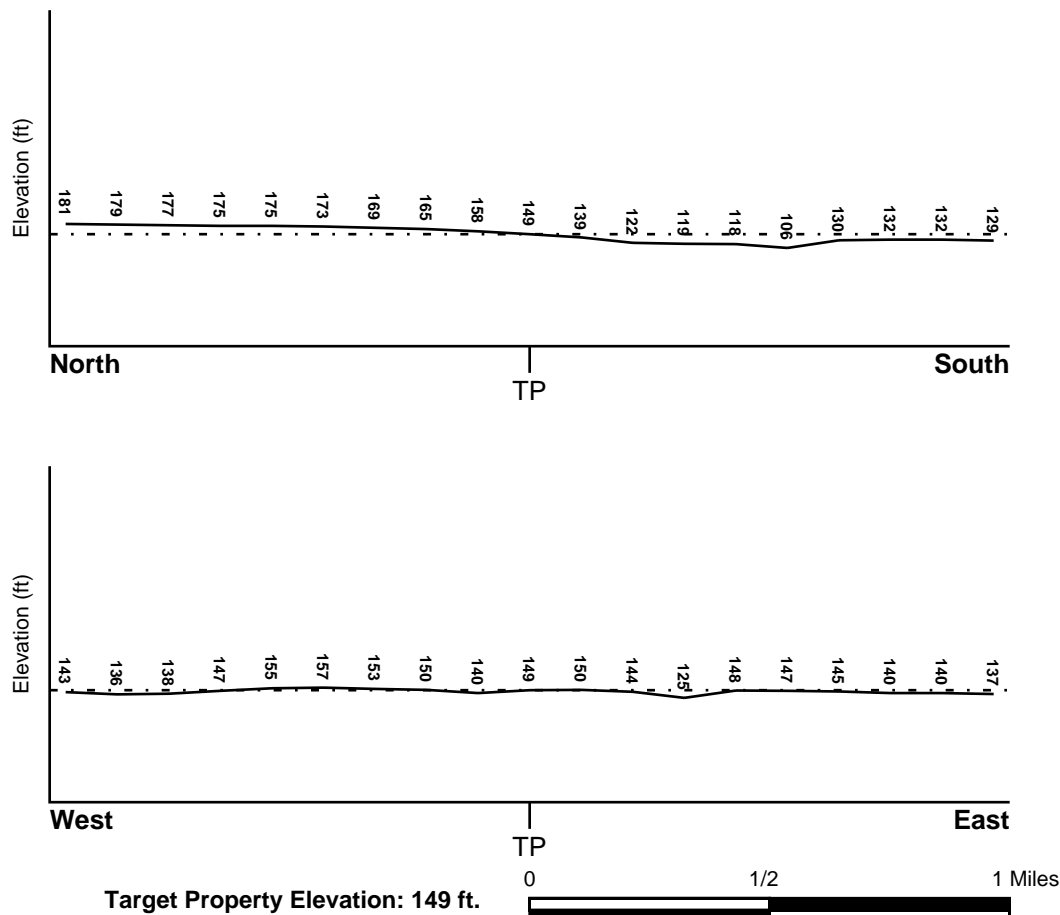
SURROUNDING TOPOGRAPHY: ELEVATION PROFILES

General Topographic Gradient: General SSE

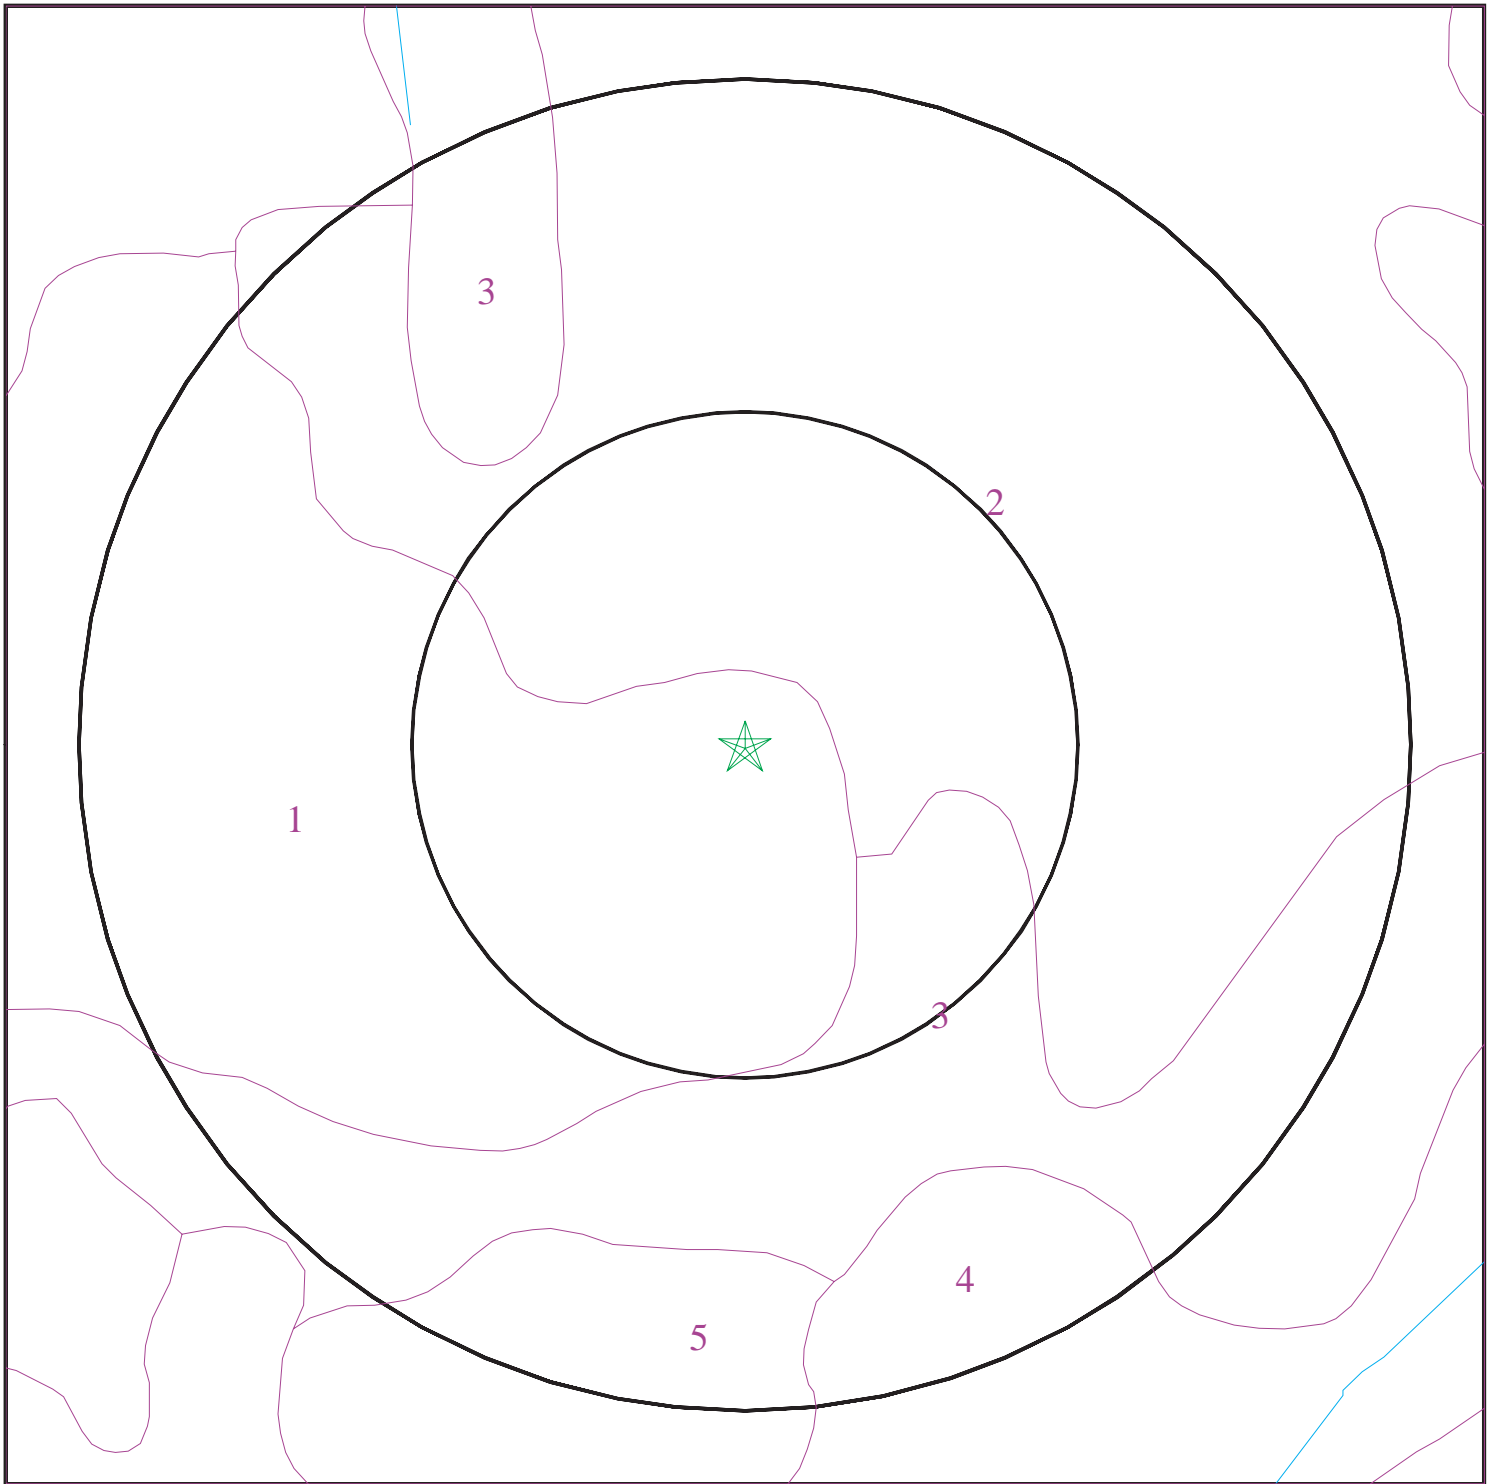
SSURGO SOIL MAP - 1975568.1s

- ★ Target Property
- SSURGO Soil
- Water

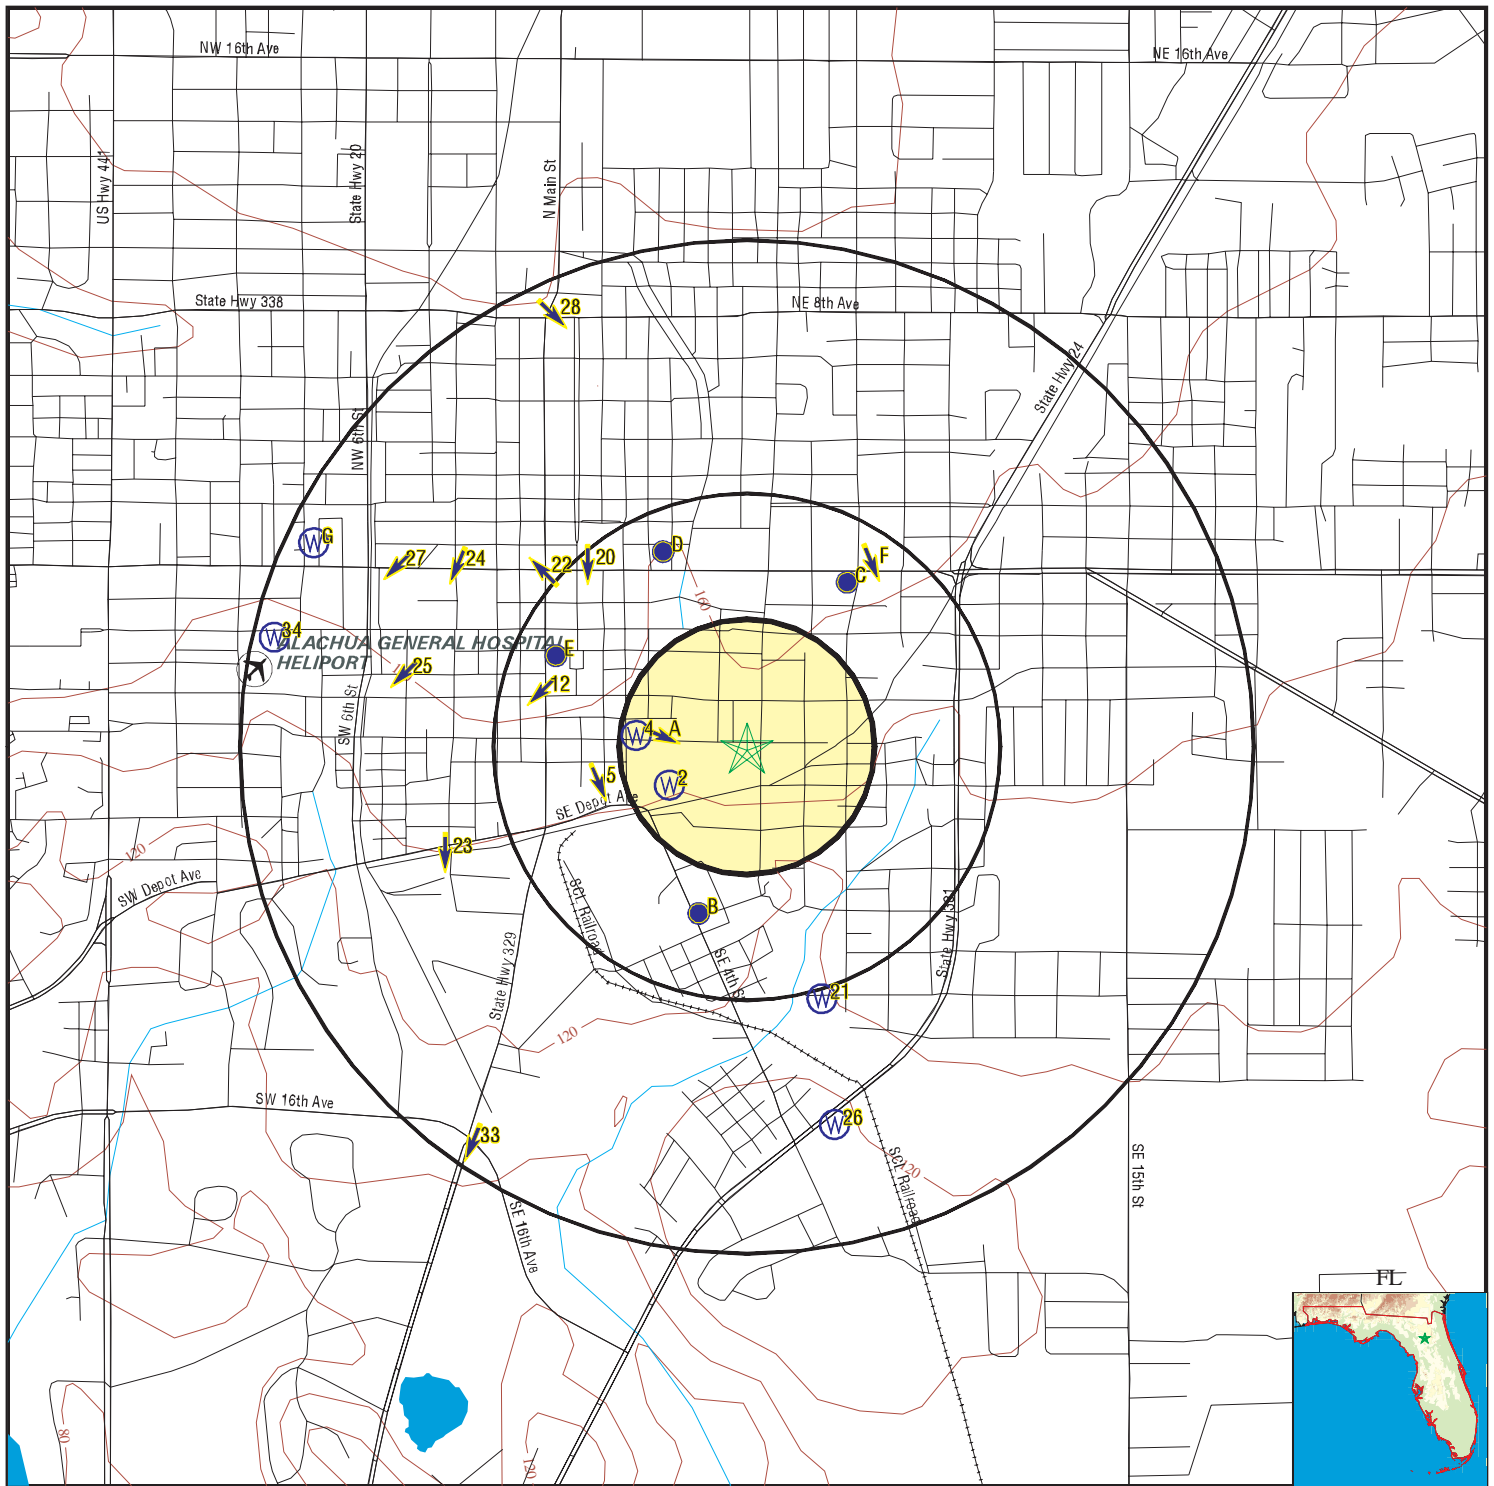
PHYSICAL SETTING SOURCE MAP - 1975568.1s

- County Boundary
- Major Roads
- Contour Lines
- Airports
- Earthquake epicenter, Richter 5 or greater
- Water Wells
- Public Water Supply Wells
- Cluster of Multiple Icons

- Groundwater Flow Direction
- Indeterminate Groundwater Flow at Location
- Groundwater Flow Varies at Location
- Closest Hydrogeological Data
- Oil, gas or related wells
- Sink holes

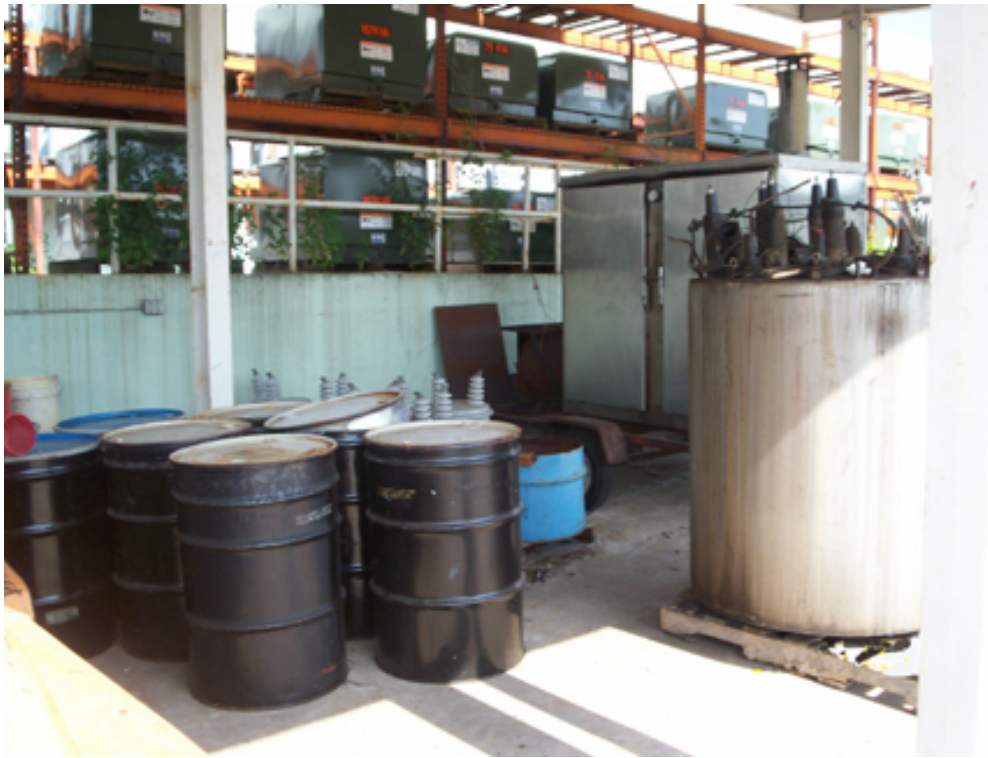
Storage drums were looked for during the site visit. Eight 55-gallon metal drums were located near the exterior of the warehouse on the southwest portion of the property. The drums contained used oil filters, rags and trash. There were not labeled on the drums and the drums were not elevated off the concrete. No staining was noted around the drums.

Photograph 1—Storage drums and transformers were located on the west portion of the property.

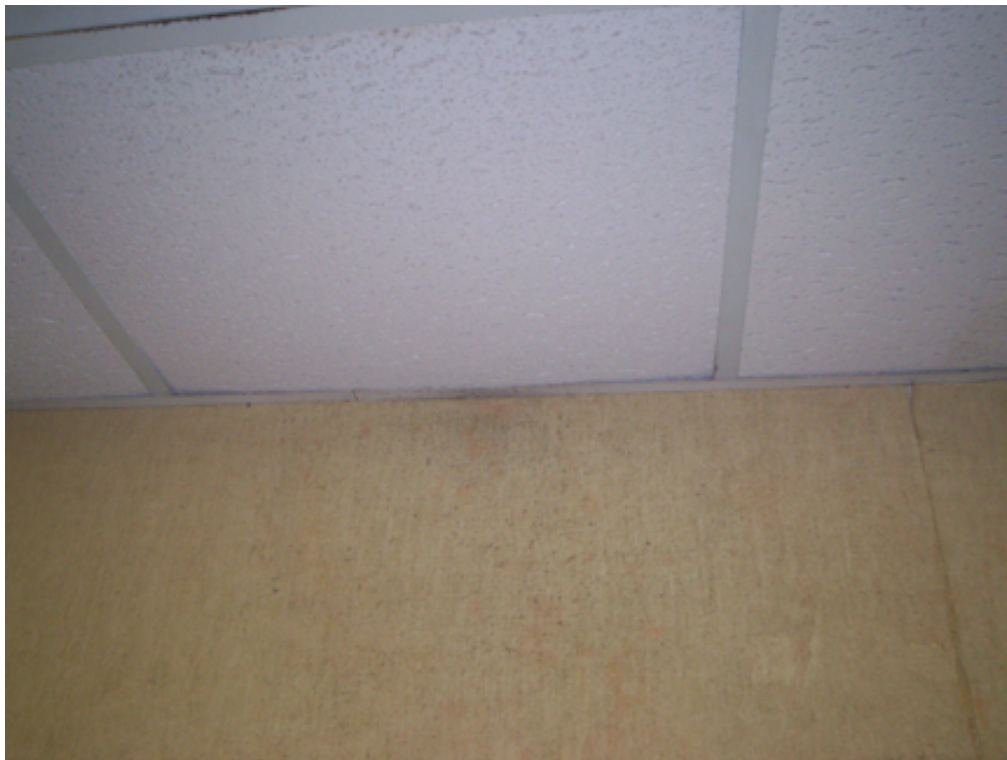
Areas of stains or corrosion of floors, walls, or ceilings in buildings were looked for during the site visit. Stained ceiling tiles were noted in all of the office buildings. In addition, there was staining on the walls in the office buildings located on the northwest portion of the property due to possible mold.

Photograph 2—GRU Operation Center office space. Staining was noted on the wallpaper in the break room.
