POWER DISTRICT BUILDING NEEDS ASSESSMENTS

May 2015

Gainesville
Community
Redevelopment
Agency

WALKER
ARCHITECTS

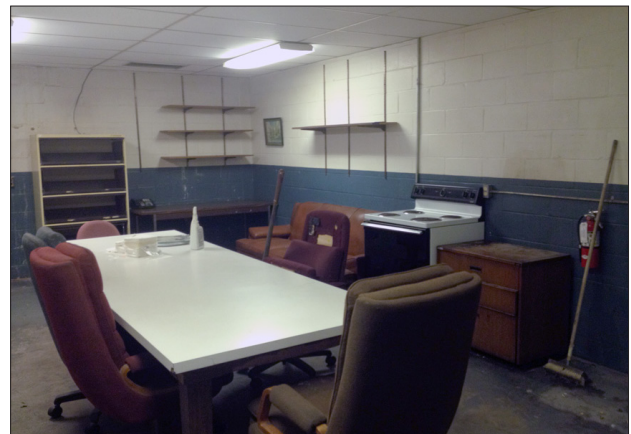
Break Room With Cement Floor

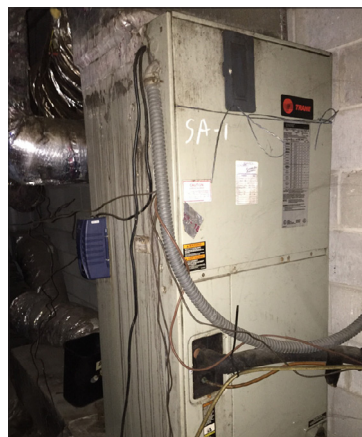
Offices	Cooling: Offices are cooled by a combination of split-system AC units, window AC units and a packaged AC unit. All units are past their expected serviceable life. The second floor heat pump does not have code-required access for maintenance. Most ductwork is comprised of flexible duct attached to galvanized mains. All visible ductwork is in poor condition.	Provide outside air energy recovery unit to supply ventilation air where natural ventilation is not available.
	Heating: Heating in office areas is provided as part of each cooling system.	Demolish and replace existing cooling and heating units with new heat pumps and controls.
	Ventilation: Existing ventilation is provided by operable windows in most spaces. Some office areas do not have exterior openings or ducted outdoor air.	Provide outside air energy recovery unit to supply ventilation air where natural ventilation is not available.

Existing HVAC Equipment

SYSTEM	CONDITION	RECOMMENDATION
Maintenance Bays	Cooling: The maintenance bays in Building A are not mechanically cooled.	Demolish and replace existing cooling and heating units with new heat pumps and controls.
	Heating: The main maintenance bay has LP gas unit heaters installed. The heaters appear to be in serviceable condition. The northeast bay is heated by an LP gas fan heating unit with uninsulated galvanized steel ductwork. The heating unit appears to be in serviceable condition.	Demolish existing process ductwork not connected to equipment.
	Ventilation: Maintenance bay ventilation consists of operable doors and wall-mounted propeller exhaust fans (total of five). The exhaust fans are rusted and appear to be beyond their expected serviceable life.	Demolish existing process ductwork not connected to equipment.
Storage Rooms	Storage areas in this building are not conditioned or ventilated.	Replace propeller ventilation fans serving maintenance bays.

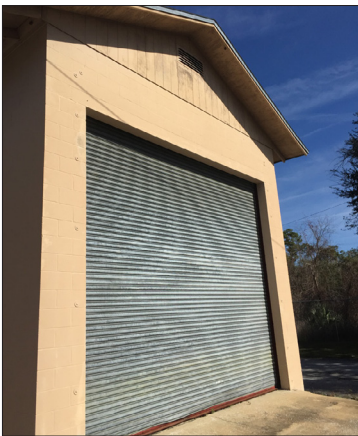
SYSTEM	CONDITION	RECOMMENDATION
Exterior Windows	None.	
Exterior Doors	Type 1: Roll-up garage doors. Door hardware and frame systems are all in good working order.

Roll-Up Door

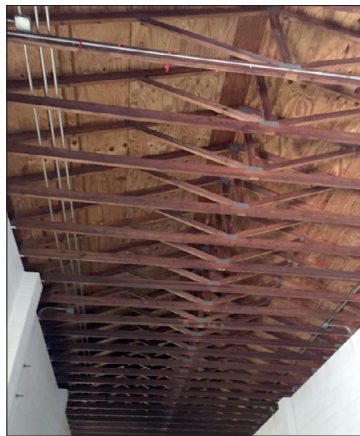
Exposed Roof Structure

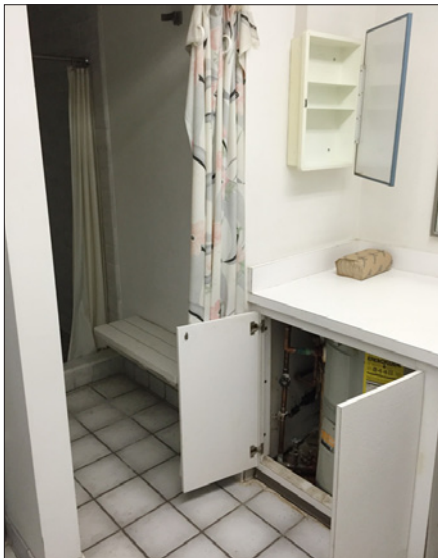
Toilet Room With Under-Counter Water Heater

Demolish existing water heating system. Reinstall water heaters as necessary for new layout.
Other	There is a sink and a water cooler in the break room. Both fixtures are old.	Demolish existing water cooler and sink. Install new water cooler and sink to serve new tenant layout.

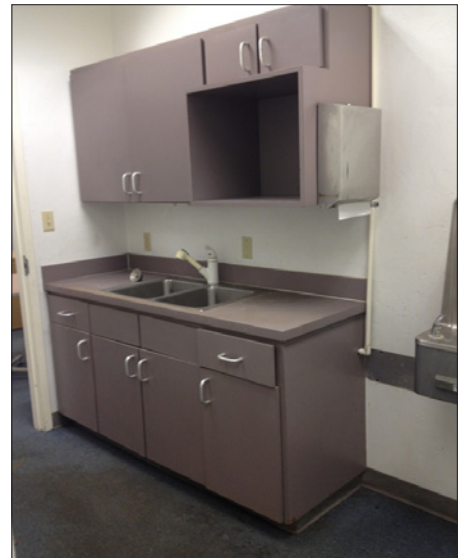
Break Room Sink

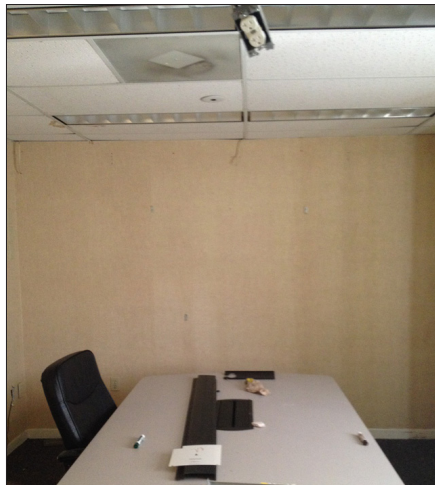
Electrical Components Hanging From Ceiling

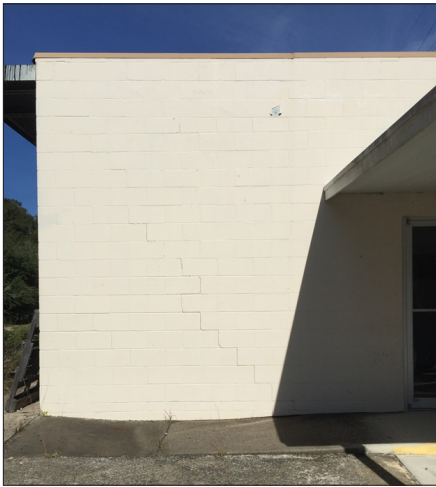
Exterior CMU

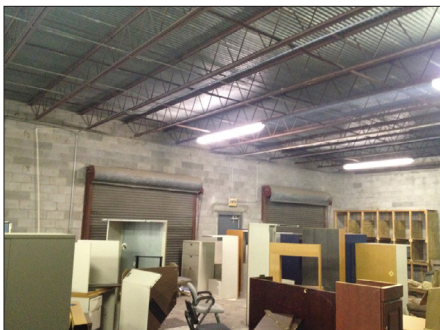
Warehouse

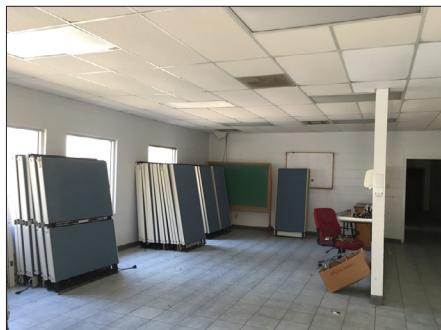
Replacement is recommended.
Ceiling System	Type 1: Office spaces have standard sound absorbent 2x2 or 2x4 acoustic ceiling tile. There has been some exposure to moisture which is evidenced by the sagging tiles.

Office With Sagging Ceiling Tile

Replacement is recommended.

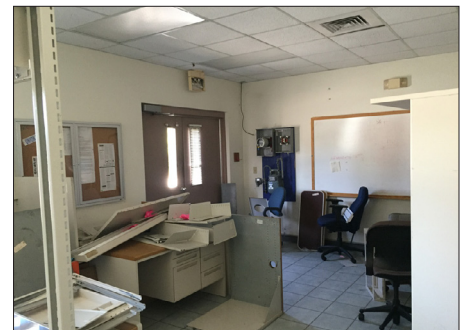
Office

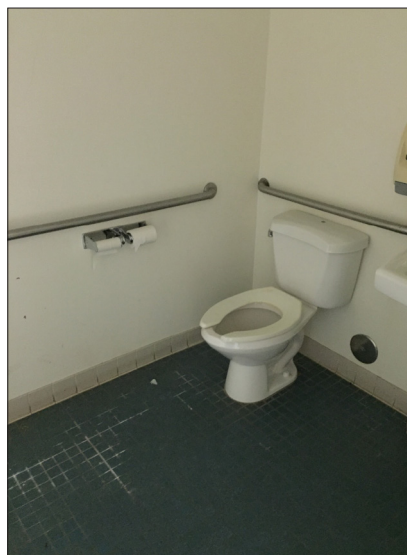
Toilet Room

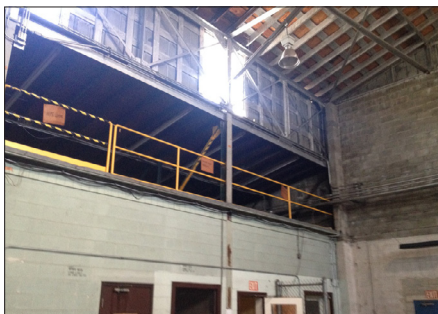
Warehouse Mezzanine

The warehouse area is in fair condition and could be used as-is for manufacturing or warehouse uses that do not require significant humidity or temperature control. The south oriented mezzanine should not be utilized as-is. The office areas should be completely renovated if they are to be reused. The office renovation scope of work includes, but is not limited to floor, wall and ceiling finishes.

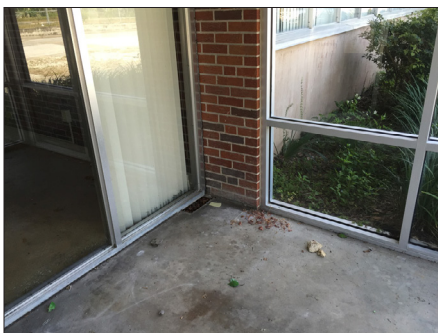
Storefront

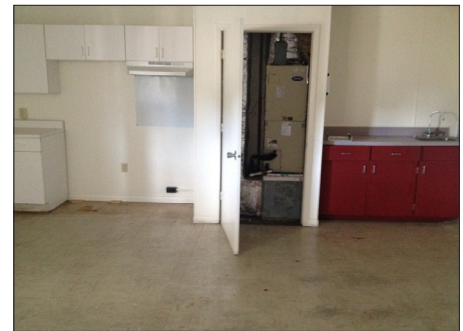
Mechanical Closet In Break Room

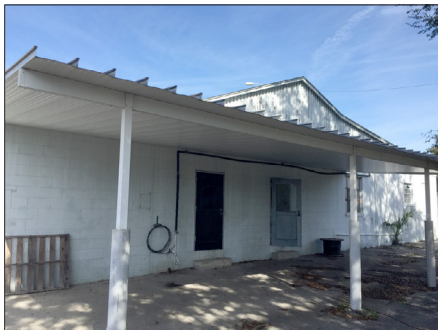
Exterior

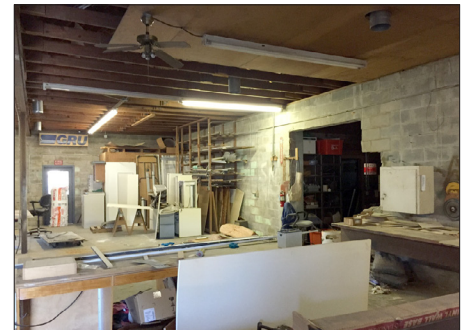
Shop Interior

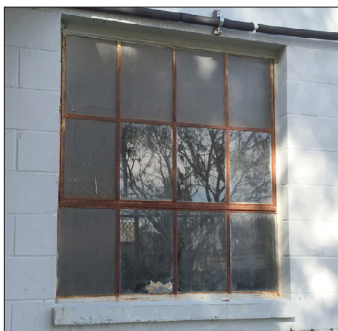
Rusting Window Panes

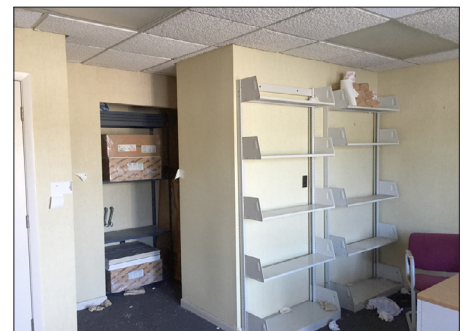
Office Area

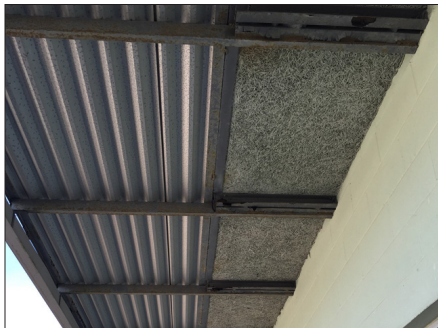
Roof Deck

Repair water damage and roof leaks.

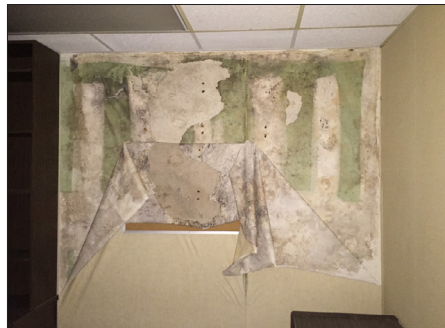
Mold Growth On Interior Wall

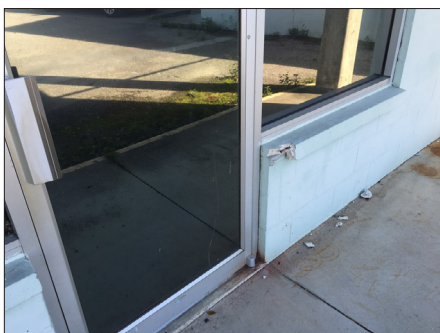
SYSTEM	CONDITION	RECOMMENDATION
Exterior Windows	All exterior storefront glazing and sealant systems are in fair condition. No leaks or potential leaks were noted on initial walk-through.

Storefront

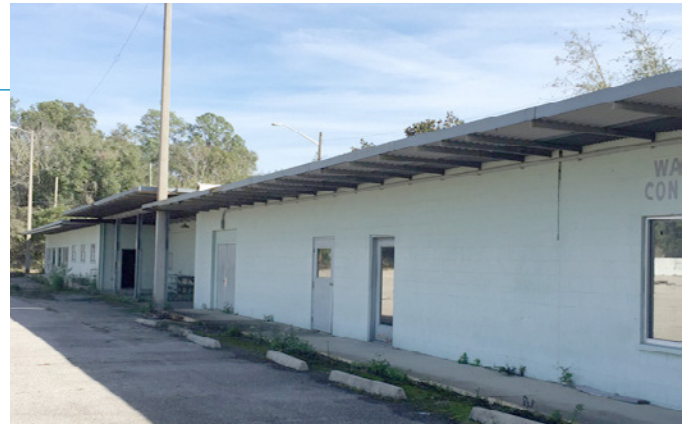
Building H - Water Distribution Construction Building

The warehouse area is in fair condition and could be used as-is for manufacturing or warehouse uses that do not require significant humidity or temperature control. The overall office area is in poor condition and should be completely renovated if it were to be reused. The office renovation scope of work includes, but is not limited to floor, wall and ceiling finishes.

Life safety and egress requirements do not appear to meet current FBC 2010 and 5th Edition Florida Fire Prevention Code requirements.

In order to prevent further decline, immediately cap plumbing and repair roof leaks.
